Design and fabrication of a non-destructive system to detect rail corrugation

The present paper proposes a technique that is capable of inspecting the rail head for corrugation before and after the grinding process with high accuracy and repeatability. The heads of the rails, at certain places, are found not straight but corrugated i.e., with a wavy surface. This phenomenon is called corrugation. It is one of the common defects of railway lines that if it is not eliminated in time by grinding operations, could cause a lot of damage. Considering the importance of inspecting the issue of the railways, the application of nondestructive methods can be an effective step to detect the defects and, consequently, prevent irreparable damage to the railway industry. In this research, a device equipped with an accelerometer has been designed and fabricated to detect and measure corrugation. The proposed system generates an immediate qualitative and numerical report to predict a proper maintenance action or check the quality of the grinding. The implemented system is part of the RDD-S11 rail defect detector equipment and is currently in use in Mashhad Urban Railway Company.

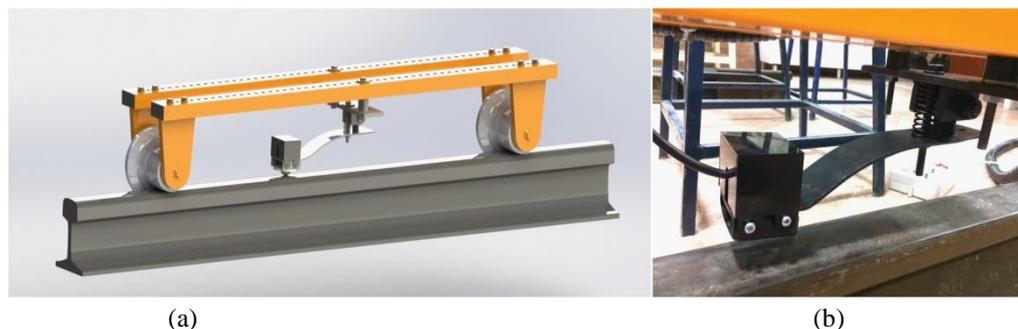
Figure 2. System designed to detect and measure corrugation, (a) computer model and (b) actual image.
