Design and fabrication of a non-destructive system to detect rail corrugation

The present paper proposes a technique that is capable of inspecting the rail head for corrugation before and after the grinding process with high accuracy and repeatability. The heads of the rails, at certain places, are found not straight but corrugated i.e., with a wavy surface. This phenomenon is called corrugation. It is one of the common defects of railway lines that if it is not eliminated in time by grinding operations, could cause a lot of damage. Considering the importance of inspecting the issue of the railways, the application of nondestructive methods can be an effective step to detect the defects and, consequently, prevent irreparable damage to the railway industry. In this research, a device equipped with an accelerometer has been designed and fabricated to detect and measure corrugation. The proposed system generates an immediate qualitative and numerical report to predict a proper maintenance action or check the quality of the grinding. The implemented system is part of the RDD-S11 rail defect detector equipment and is currently in use in Mashhad Urban Railway Company.

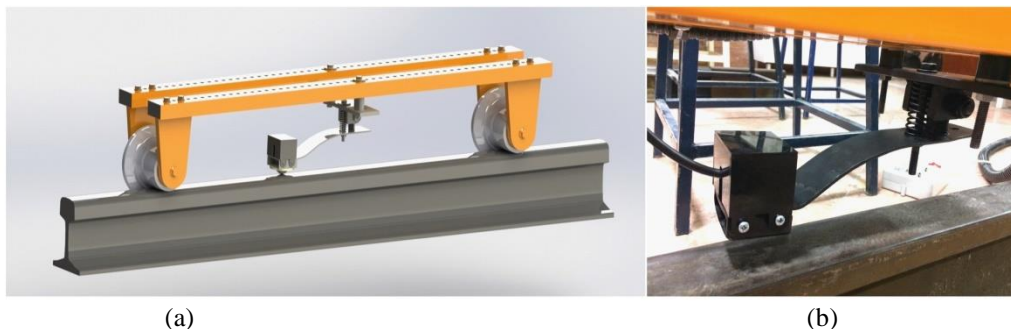
Figure 2. System designed to detect and measure corrugation, (a) computer model and (b) actual image.

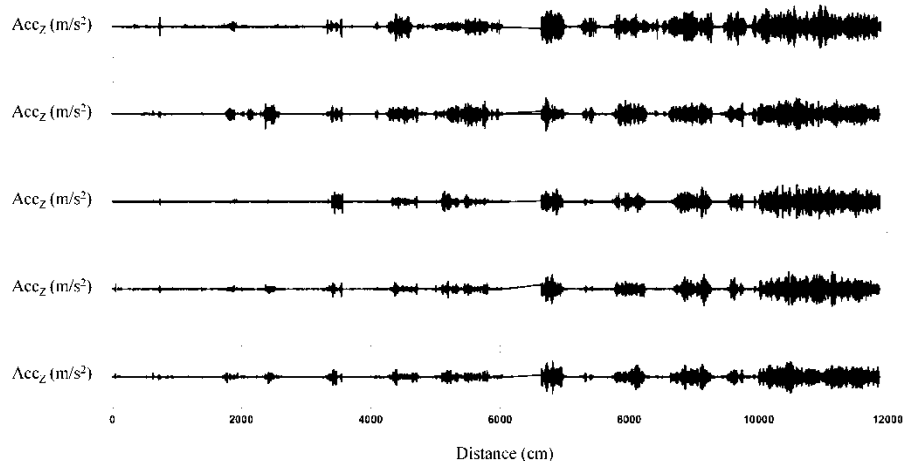
Figure 4. Results of rail surface scanning by corrugation detection and measurement system in a 120-meter path.

The results of corrugation measurement with the RDD-S11 are shown in Figure (4). In the 12,000 cm inspected region, in some positions, a change in outputs is observed in the form of noise. The pattern of the noises and their intensity are following the data obtained from visual inspection. For example, an increase in the intensity of corrugation is observed in the final parts of the region in both Figures (3) and (4). It is worth noting that the data obtained from the proposed non-destructive measurement system contain more information than visual inspection. Especially, corrugations with too low depths could not be seen by the naked eyes, but the sensitivity of the proposed method is high enough to detect minor changes and it could detect those hidden corrugations. The same trend of five inspections is another important point that could be seen in Figure (4). This indicates the high repeatability of the method, which confirms the equipment's proper performance in detecting the position and intensity of the corrugation. For a closer look, Figures (5) and (6) show the information related to rail surface sweep by the proposed system to detect and measure corrugation in low and high ranges, respectively. The information obtained from these two figures is fully consistent with the data obtained from the visual inspection and is a confirmation of the correct operation of the measurement system.

Comparing the results of Figures 4 to 6 with the results of visual inspections in the scanned path shows that an increase in corrugation intensity (increasing depth) increases the peak intensity in the acceleration change curve. This, as a criterion, can be used to diagnose
