Design and fabrication of a non-destructive system to detect rail corrugation

The present paper proposes a technique that is capable of inspecting the rail head for corrugation before and after the grinding process with high accuracy and repeatability. The heads of the rails, at certain places, are found not straight but corrugated i.e., with a wavy surface. This phenomenon is called corrugation. It is one of the common defects of railway lines that if it is not eliminated in time by grinding operations, could cause a lot of damage. Considering the importance of inspecting the issue of the railways, the application of nondestructive methods can be an effective step to detect the defects and, consequently, prevent irreparable damage to the railway industry. In this research, a device equipped with an accelerometer has been designed and fabricated to detect and measure corrugation. The proposed system generates an immediate qualitative and numerical report to predict a proper maintenance action or check the quality of the grinding. The implemented system is part of the RDD-S11 rail defect detector equipment and is currently in use in Mashhad Urban Railway Company.

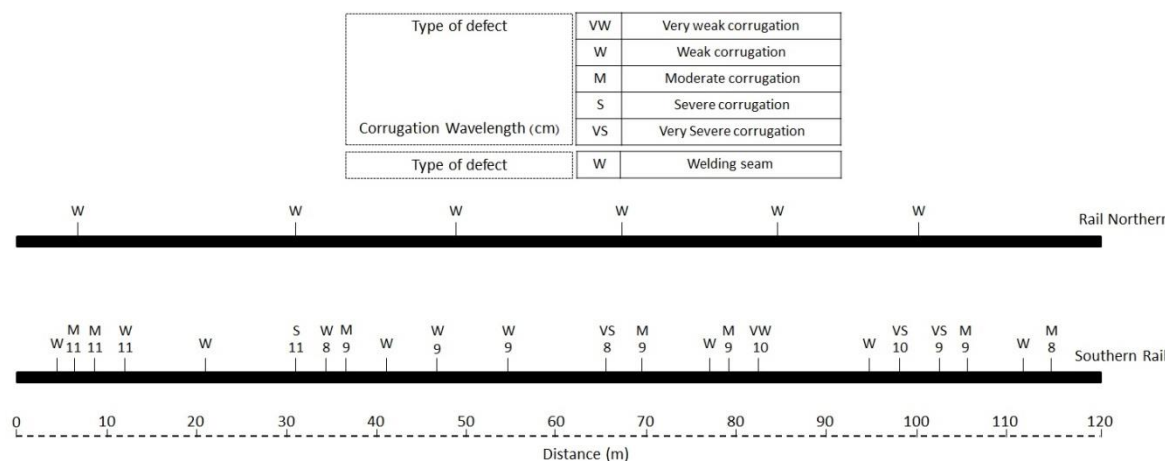
Figure 3. Results of visual inspection of corrugation detection in a 120-meter path of the railway lines of Mashhad Urban Railway Company.

After a complete search, a region with a length of 120 meters on line one of Mashhad Urban Railway Company was inspected based on the proposed system. At that time, some locations in that region suffered from a significant corrugation. To evaluate the repeatability of the proposed method, the inspection was repeated five times. Figure (3) shows the exact positions of the corrugation resulting from the visual inspection along this region. As the figure shows, in addition to the position and intensity of the existing corrugations, the position of the welding seam of the rails is also recorded in the southern and northern rails of the path. This figure also indicates that the intensity of corrugation has increased at the end of the path.

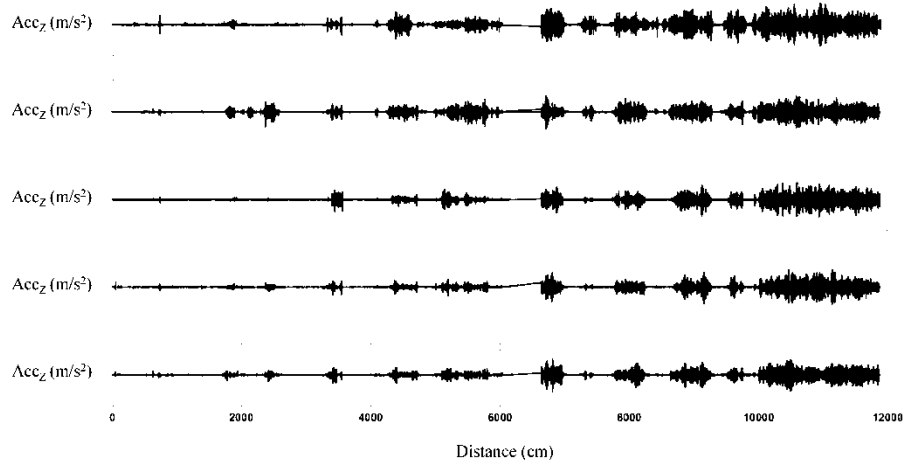
Figure 4. Results of rail surface scanning by corrugation detection and measurement system in a 120-meter path.

The results of corrugation measurement with the RDD-S11 are shown in Figure (4). In the 12,000 cm inspected region, in some positions, a change in outputs is observed in the form of noise. The pattern of the noises and their intensity are following the data obtained from visual inspection. For example, an increase in the intensity of corrugation is observed in the final parts of the region in both Figures (3) and (4). It is worth noting that the data obtained from the proposed non-destructive measurement system contain more information than visual inspection. Especially, corrugations with too low depths could not be seen by the naked eyes, but the sensitivity of the proposed method is high enough to detect minor changes and it could detect those hidden corrugations. The same trend of five inspections is another important point that could be seen in Figure (4). This indicates the high repeatability of the method, which confirms the equipment's proper performance in detecting the position and intensity of the corrugation. For a closer look, Figures (5) and (6) show the information related to rail surface sweep by the proposed system to detect and measure corrugation in low and high ranges, respectively. The information obtained from these two figures is fully consistent with the data obtained from the visual inspection and is a confirmation of the correct operation of the measurement system.

Comparing the results of Figures 4 to 6 with the results of visual inspections in the scanned path shows that an increase in corrugation intensity (increasing depth) increases the peak intensity in the acceleration change curve. This, as a criterion, can be used to diagnose
