## Design and fabrication of a non-destructive system to detect rail corrugation

The present paper proposes a technique that is capable of inspecting the rail head for corrugation before and after the grinding process with high accuracy and repeatability. The heads of the rails, at certain places, are found not straight but corrugated i.e., with a wavy surface. This phenomenon is called corrugation. It is one of the common defects of railway lines that if it is not eliminated in time by grinding operations, could cause a lot of damage. Considering the importance of inspecting the issue of the railways, the application of nondestructive methods can be an effective step to detect the defects and, consequently, prevent irreparable damage to the railway industry. In this research, a device equipped with an accelerometer has been designed and fabricated to detect and measure corrugation. The proposed system generates an immediate qualitative and numerical report to predict a proper maintenance action or check the quality of the grinding. The implemented system is part of the RDD-S11 rail defect detector equipment and is currently in use in Mashhad Urban Railway Company.

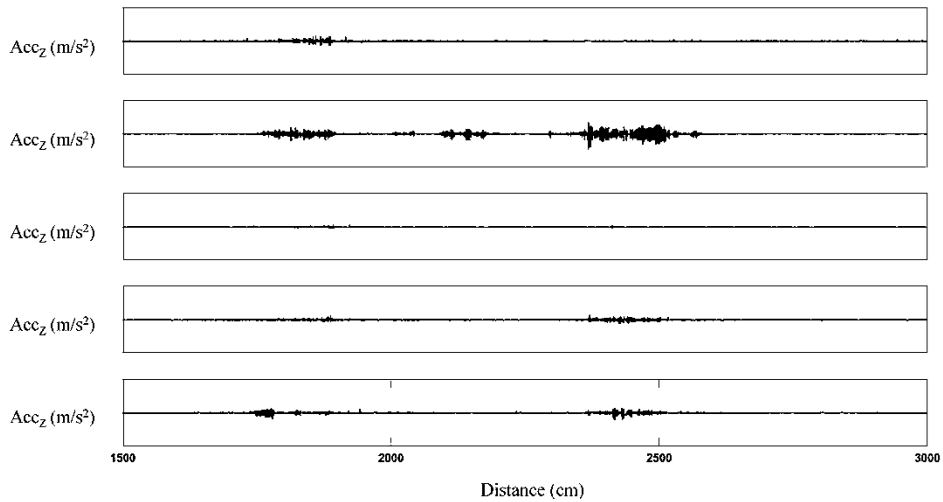
Figure 5. Results of rail surface scanning at a distance of 1500 to 3000 cm from the path of 12000 cm (area with a low degree of corrugation defect).

Comparing the results of Figures 4 to 6 with the results of visual inspections in the scanned path shows that an increase in corrugation intensity (increasing depth) increases the peak intensity in the acceleration change curve. This, as a criterion, can be used to diagnose

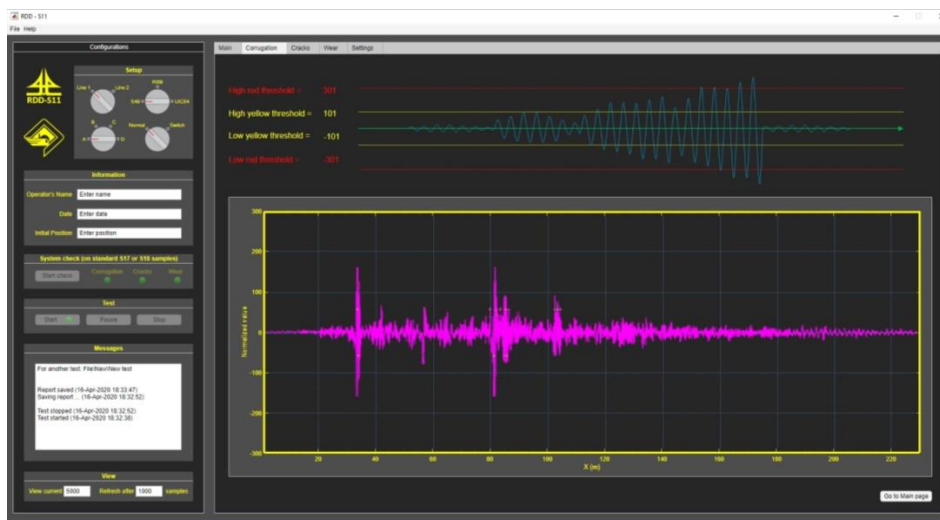
Figure 7. Corrugation page in rail defect detector (RDD-S11) software.

corrugation and its severity. For this purpose, in the corrugation page of the RDD-S11 software (Figure 7), it is possible to define thresholds to determine the ranges where the amount of corrugation exceeds the acceptable limit. If the peak intensity of a corrugation passes the moderate or severe thresholds, a yellow or red alarm will appear respectively in the software on to the correct position of the defect. Thus, after calibration, using this simple method, it is possible to detect the corrugation defect, its position, and intensity according to the defined thresholds.
